Meadows of Seven Point HOA
Requirements for the Maintenance of the Earhart Stormwater Retention Pond
6/09/23

TPM Environmental & Construction Services	
Client: MOSP HOA	Site Name: Earhart Pond
Project Number:	<p>The Blue line in this drawing represents the pathways from the 3 infalls to the outlet. These pathways were excavated in 2023. They should be cleared once to twice per year.</p> <p>Location: 3809 Leona Pass Nashville TN 37076</p>
Photographer Rdw 1

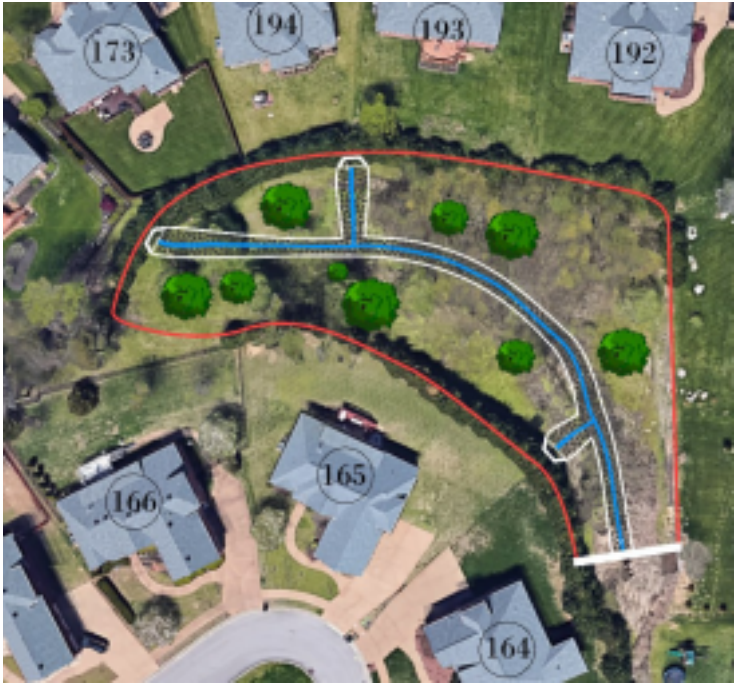
Date: 2 22 23 _M DD YR	
Direction: South	
Location: Earhart Pond	
PRO No:	
Desc. Projected Maintenance to Earhart Pond

4. During the 2023 cleanup by TPM pathways were excavated from the infalls leading water toward the exit pipe in the wall. These pathways must be maintained clear of woody growth to allow for the best opportunity to prevent ponding and the area turning into a swamp.

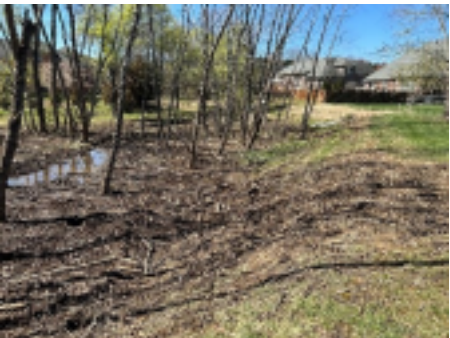
<p>Desc.</p> <p>Outfall locations #1,#2,#3 for Earhart Pond and site conditions.</p>	 
--	--

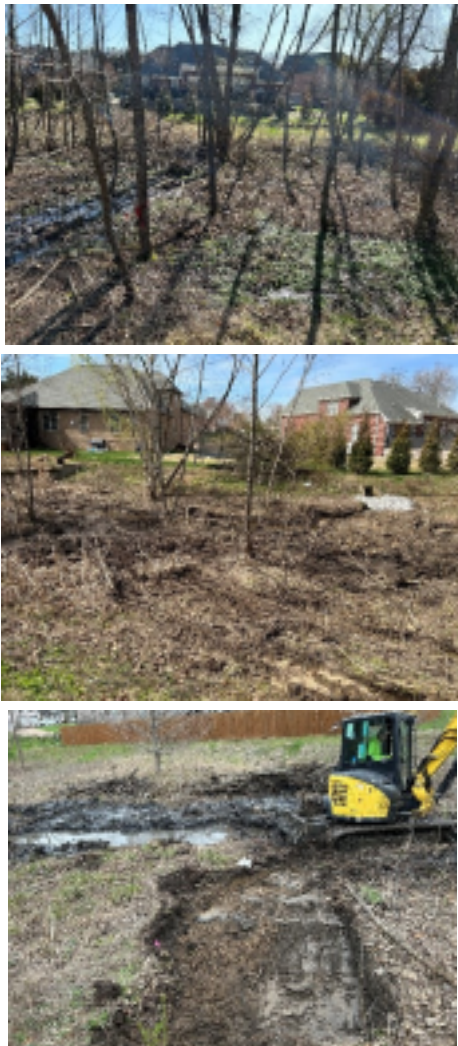
Pro No:	
Desc. Clearing process and Creek formation to match gradient flow of underground stream initiation

<p>Desc.</p> <p>Work Access Stream Delineation completion and SCM maintenance completion</p>	 
--	--

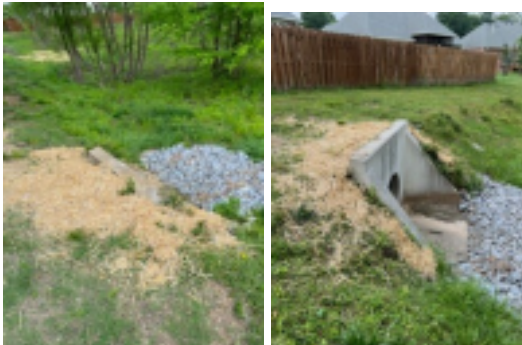
<p>Pro No:</p>	
<p>Desc. Outfalls repaired Weep wall flowing with rip rap drainage intact. Current clearing of pond showing visible signs of regrowth.</p>
